FZK-263-1  
20 OCTOBER 1965

**NERVA MATERIALS  
IRRADIATION PROGRAM**  
Volume 1  
**GTR Test 16 — AGC Materials Test**

Prepared for  
Space Nuclear Propulsion Office  
of the  
National Aeronautics and Space Administration  
Cleveland, Ohio

**NUCLEAR AEROSPACE RESEARCH FACILITY**

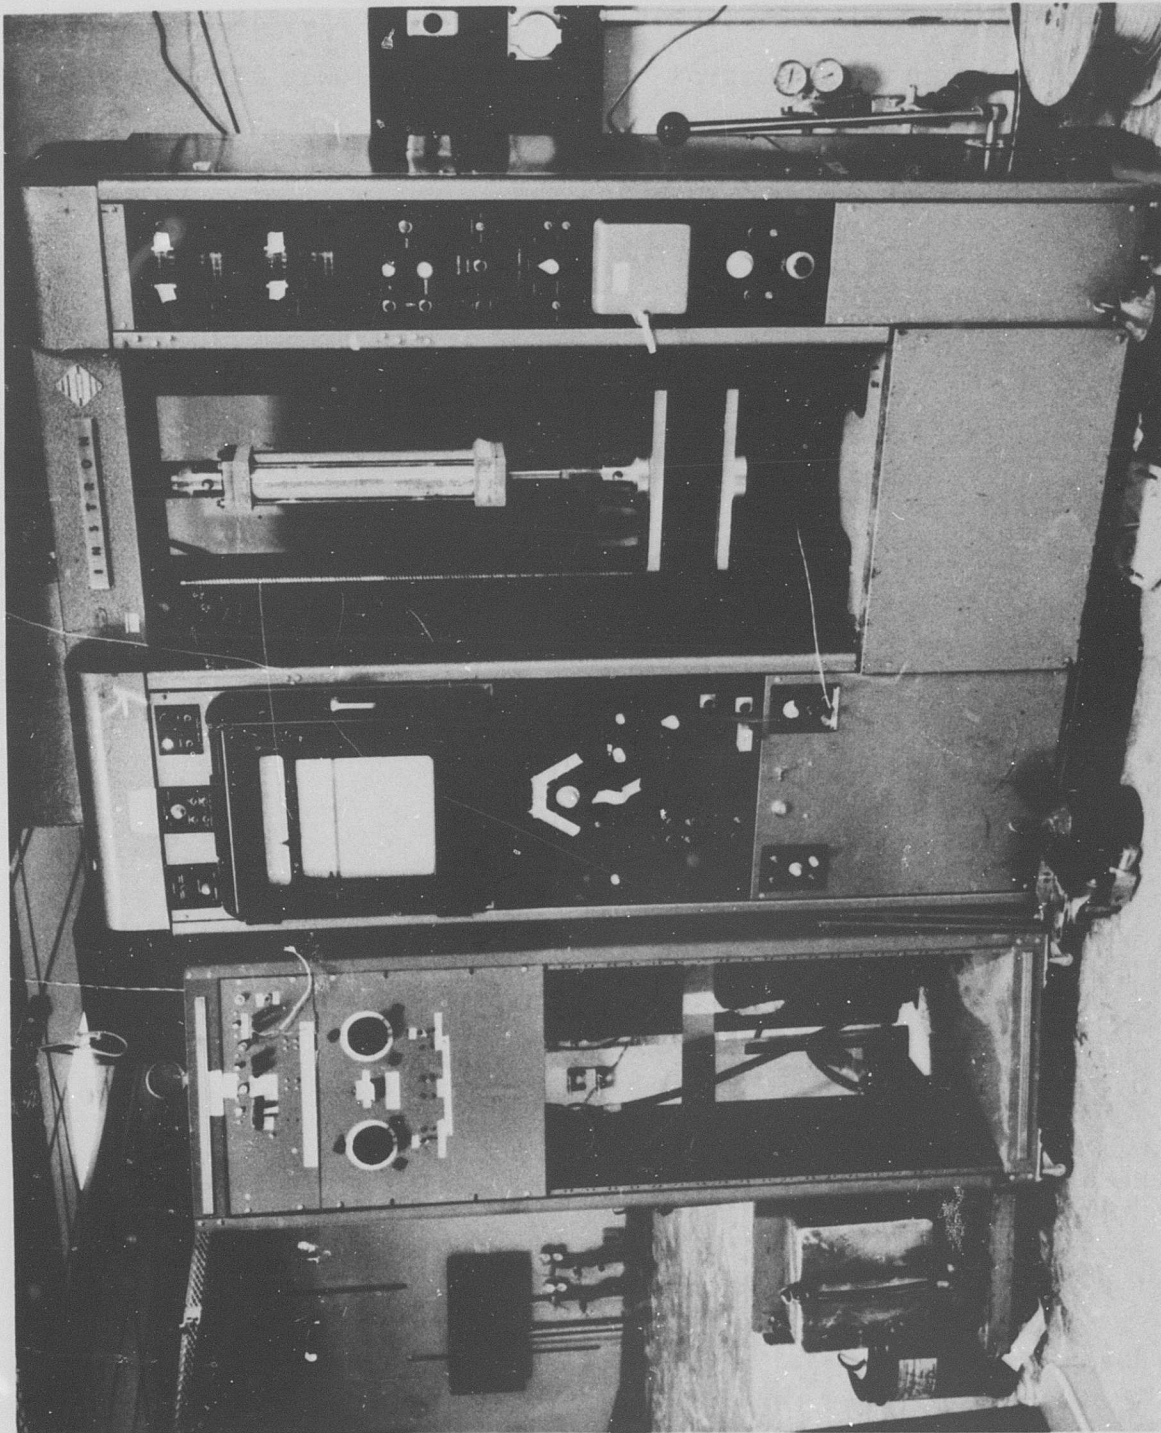
Figure 2-10 Instron Machine with Master Cylinder Installed

1. A master cylinder, which is secured between the movable crosshead and the load cell of the Instron tensile testing machine (see Fig. 2-10).
2. Four slave (or pulling) cylinders located on each assembly.
3. Pressure and return manifold gages.
4. Make-up and bleed reservoir.
5. Supply reservoir and pressure pump.
6. Interconnecting lines, valves, and fittings.

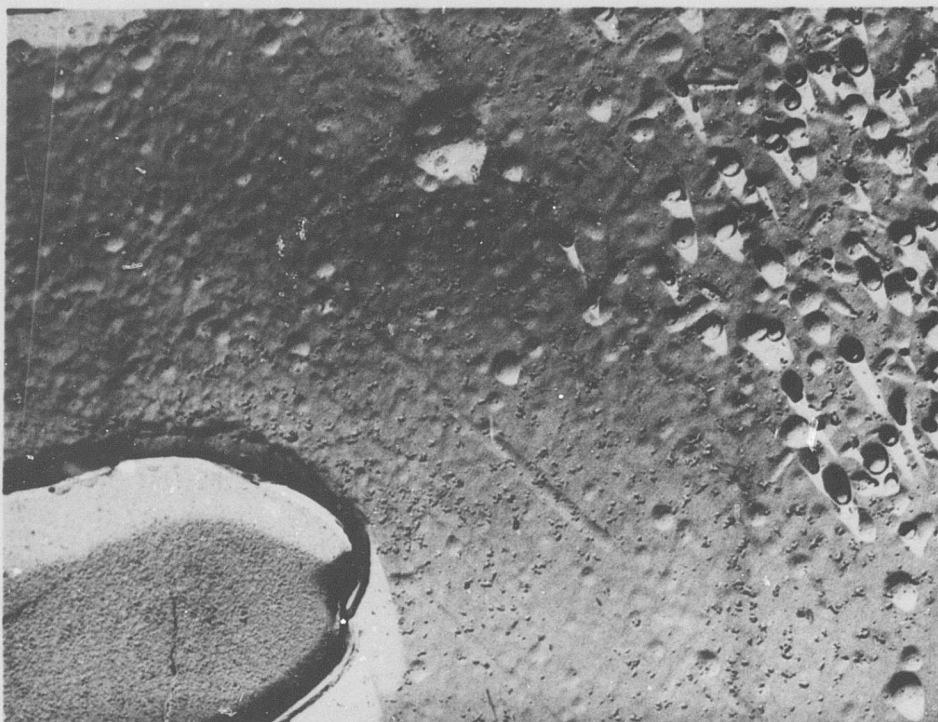
Material Aluminum A356-T6 Neg.No. 103-10  
Specimen LU 10 Neg.Mag. 7,500X  
Etchant Keller's Photo Enlargement 2X

The microstructure shows the Al-Si eutectic (lower left) and solid-solution aluminum with insolubles (right). Note strain lines between the eutectic and the insolubles.

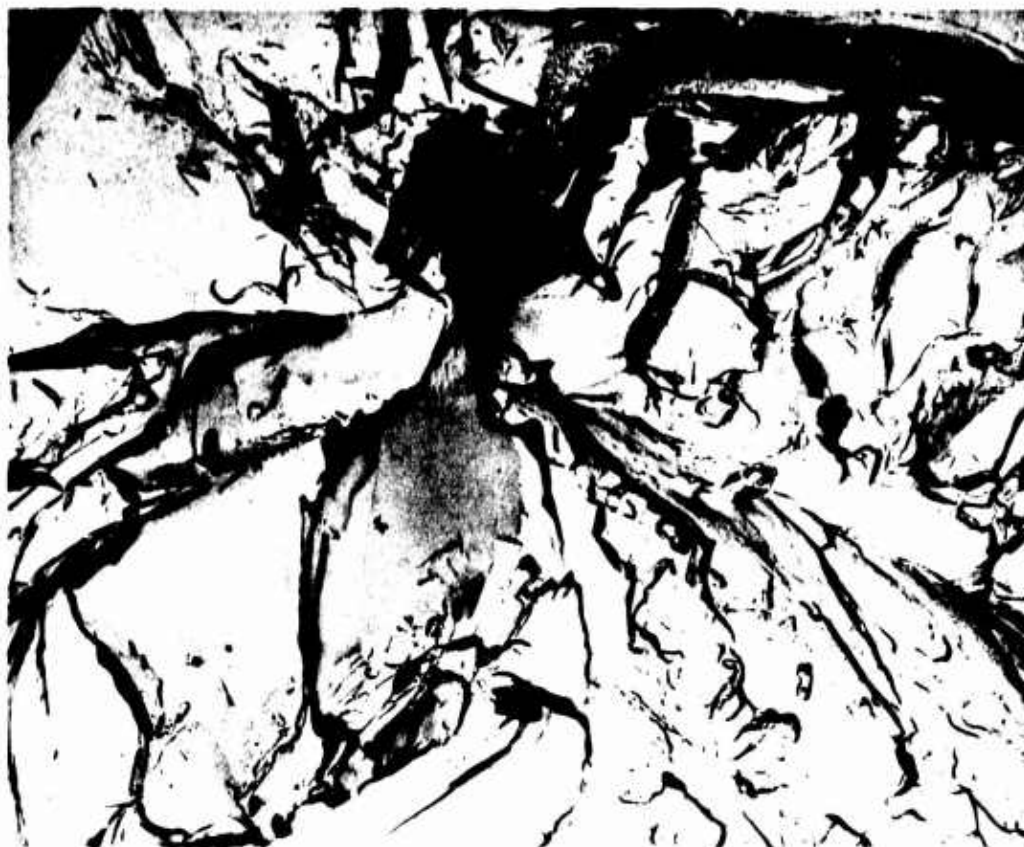
Material Aluminum A356-T6 Neg.No. 95-6  
Specimen LU 10 Neg.Mag. 2,100X  
Etchant None Photo Enlargement 2X

The topography near the edge of the fracture is made up mainly of brittle intermetallic fractures and separation along the interface between the Al-Si eutectic and the matrix. A few areas show shallow microvoid failures of the matrix.

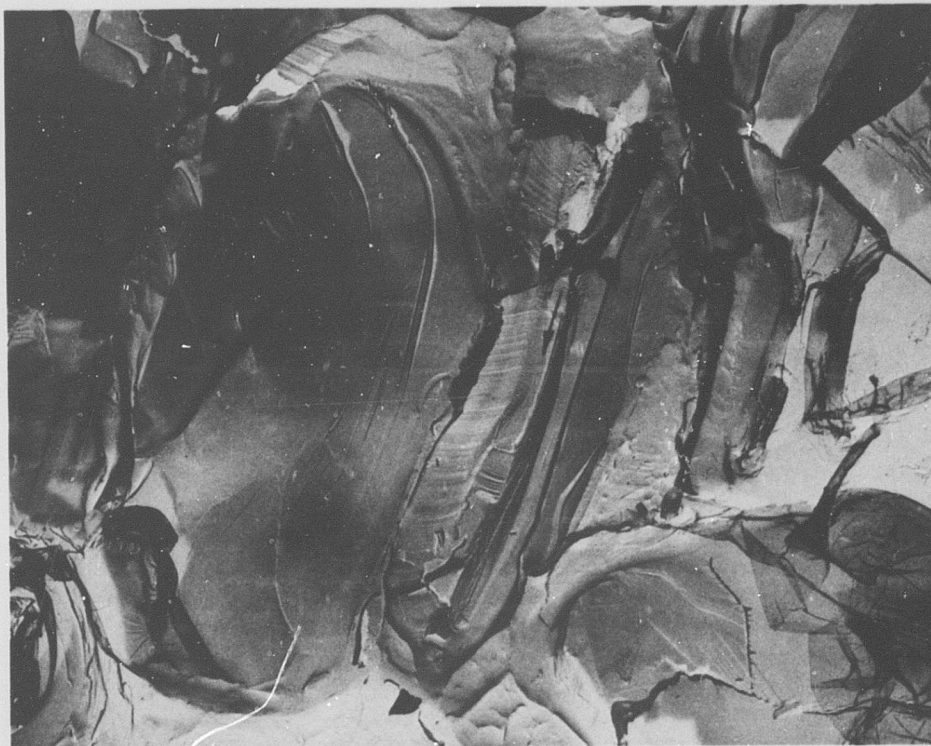
Material Aluminum A356-T6 Neg.No. 97-5  
Specimen LN 18 Neg.Mag. 2,100X  
Etchant None Photo Enlargement 2X

The notched specimen fracture displays the same characteristics as the unnotched fractures: brittle intermetallic failure, eutectic matrix separation, and isolated areas of shallow microvoids.

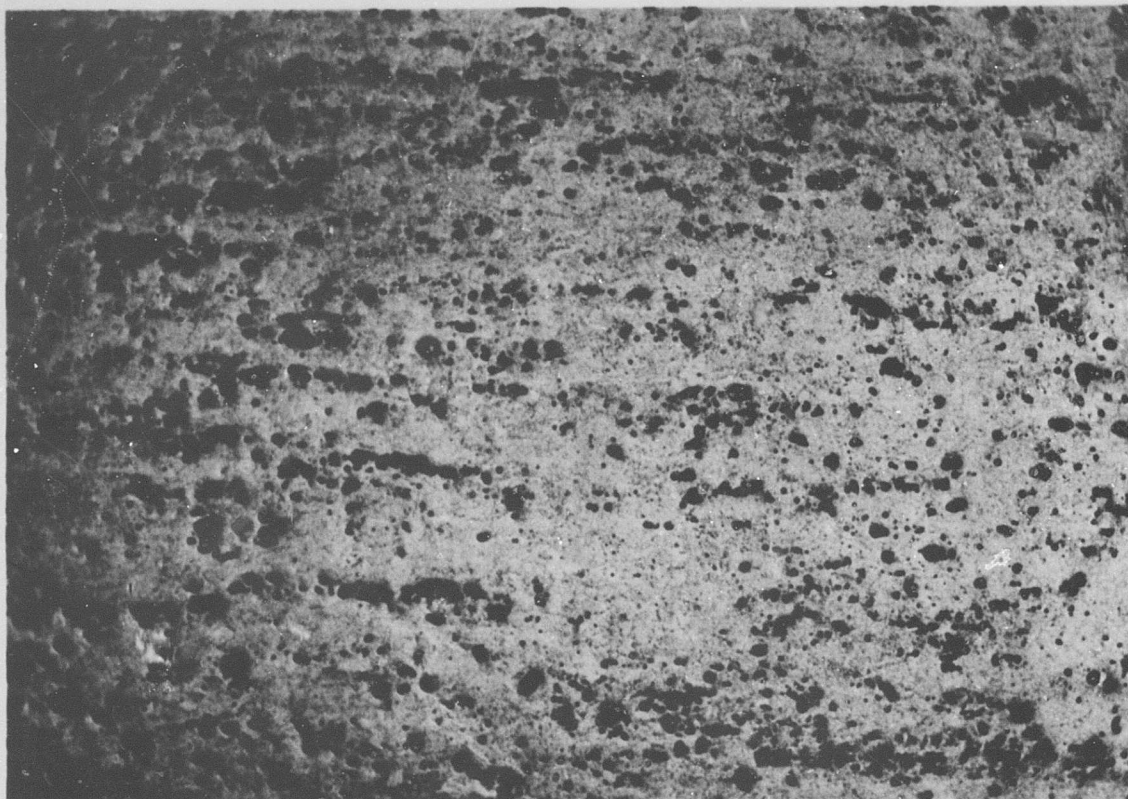
Material Aluminum 6061-T6 Neg.No. W18  
Specimen LU R-83 Neg.Mag. 100X  
Etchant Keller's Photo Enlargement None

The microstructure shows the solid-solution aluminum matrix. The matrix contains fine Mg-Si precipitate and intermetallic compounds.

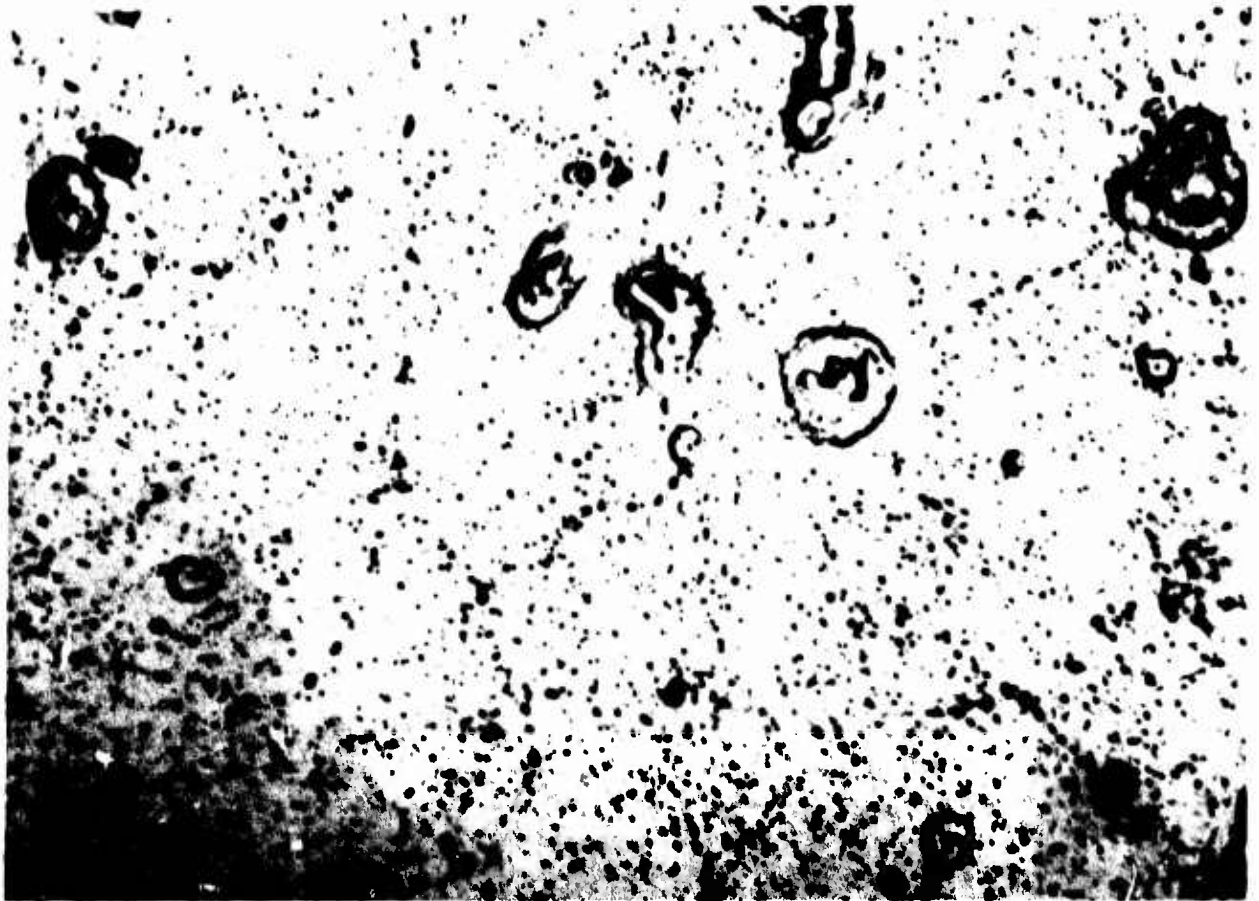
Material	Aluminum 6061-T6	Neg.No.	W30
Specimen	LU R-83	Neg.Mag.	1,000X
Etchant	Keller's	Photo Enlargement	None

The microstructure shows the solid-solution aluminum matrix with fine Mg-Si precipitate and intermetallic compounds. The precipitate outlining the grain boundary resembles that produced during a slack quenching in heat treatment.

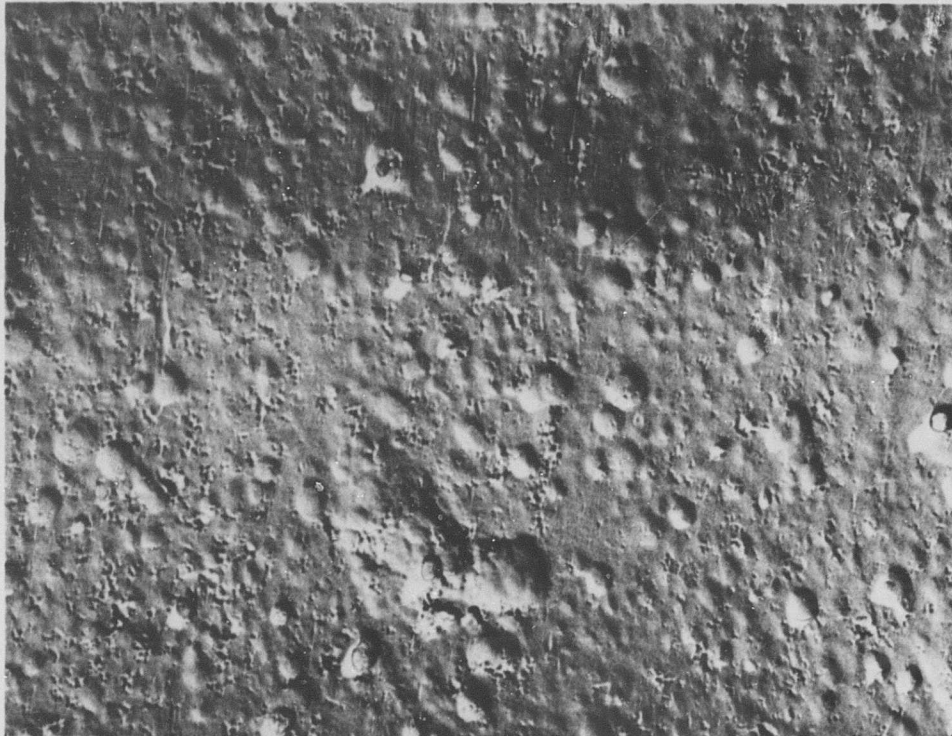
Material Aluminum 6061-T6 Neg.No. 101-4  
Specimen LU R-83 Neg.Mag. 7,500X  
Etchant Keller's Photo Enlargement 2X

The microstructure is typical of a solid-solution aluminum alloy with insolubles.

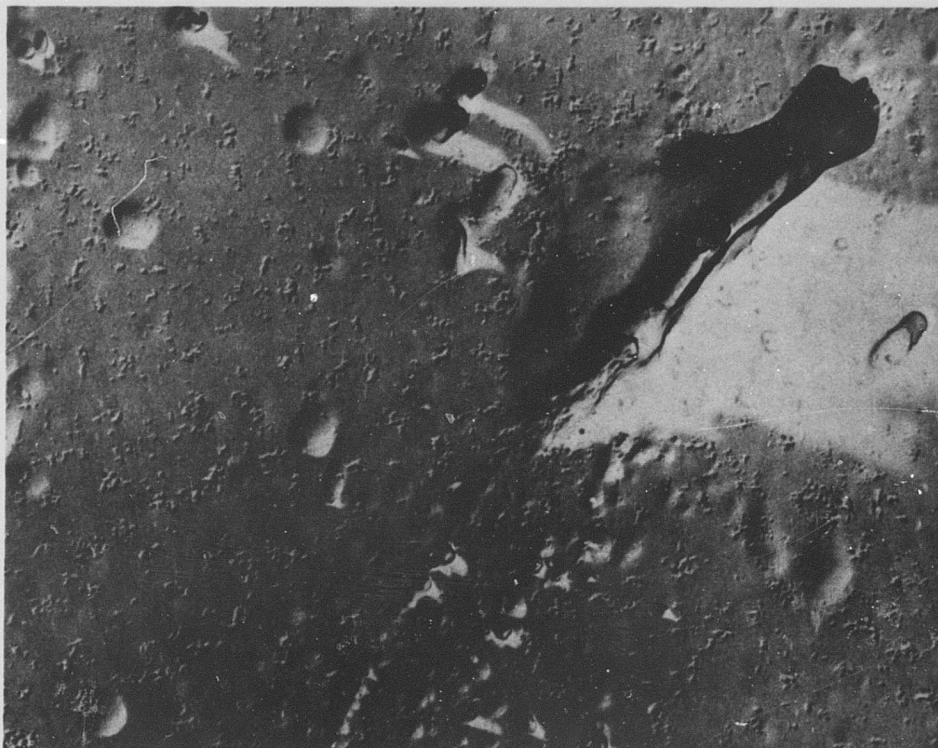
Material Aluminum 6061-T6 Neg.No. 104-3  
Specimen LWU 3-80 Neg.Mag. 7,500X  
Etchant Keller's Photo Enlargement 2X

The microstructure shows the solid-solution aluminum matrix; the Al-Si eutectic, and insolubles.

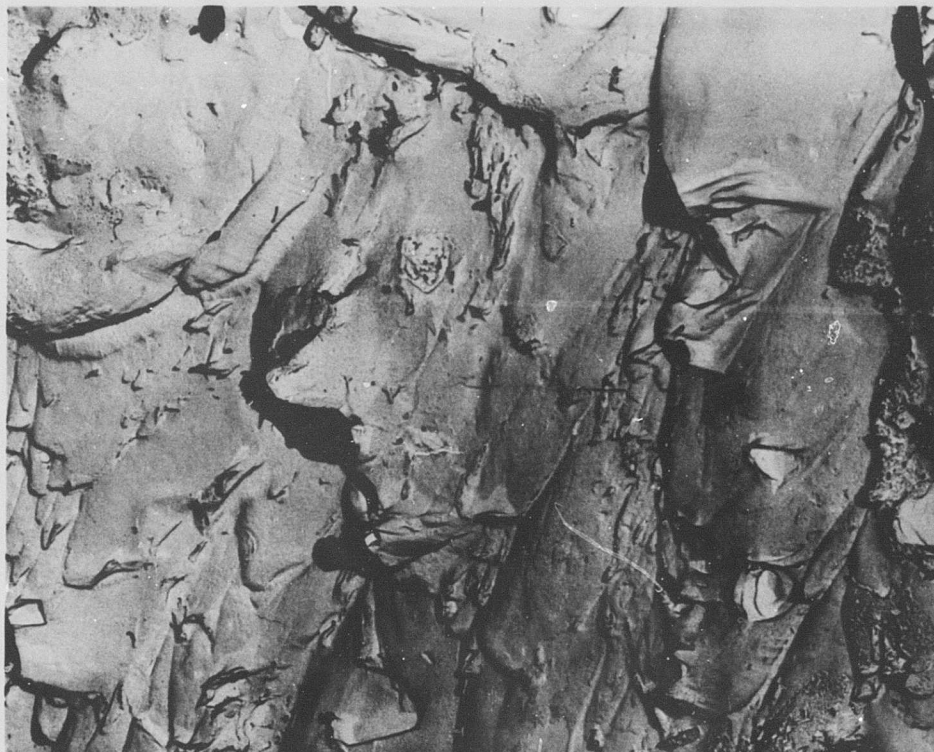
Material Aluminum 6061-T6 Neg.No. 92-12  
Specimen LWU 3-80 Neg.Mag. 2,100X  
Etchant None Photo Enlargement 2X

The topography near the edge of the fracture is composed of an oriented dimple rupture. Areas of probable oxidation can be noted.

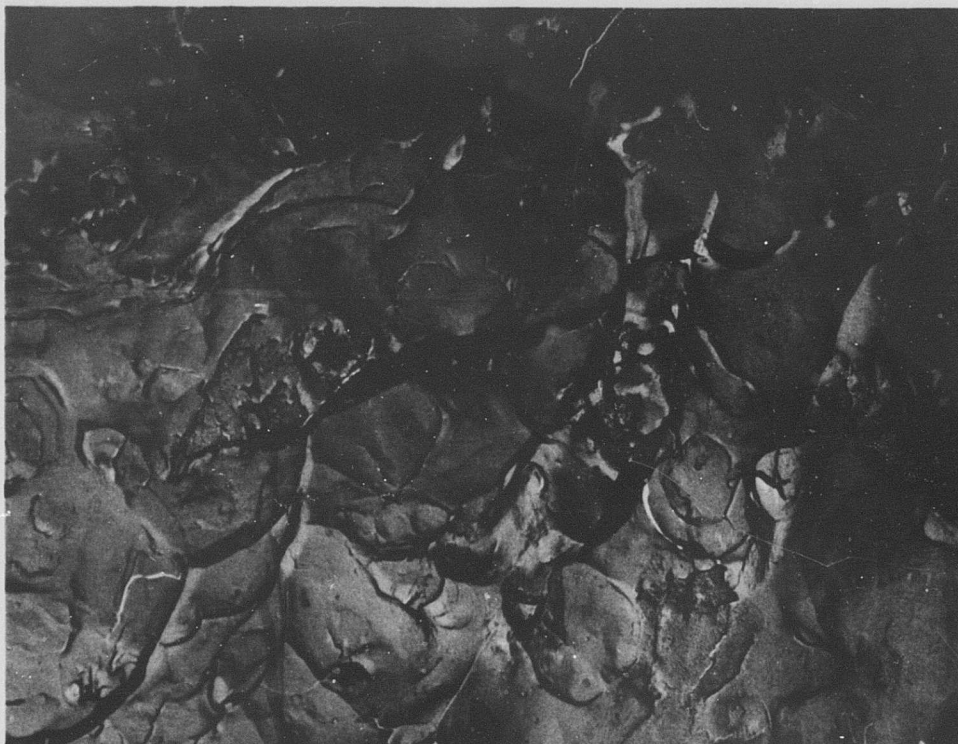
Material Aluminum 6061-T6 Neg.No. 99-9  
Specimen LWN 3-90 Neg.Mag. 2,100X  
Etchant None Photo Enlargement 2X

The notched fracture topography is made up of dimples, with eutectic at the base of the dimples. In some areas, the fracture appears to follow the eutectic/matrix interface.

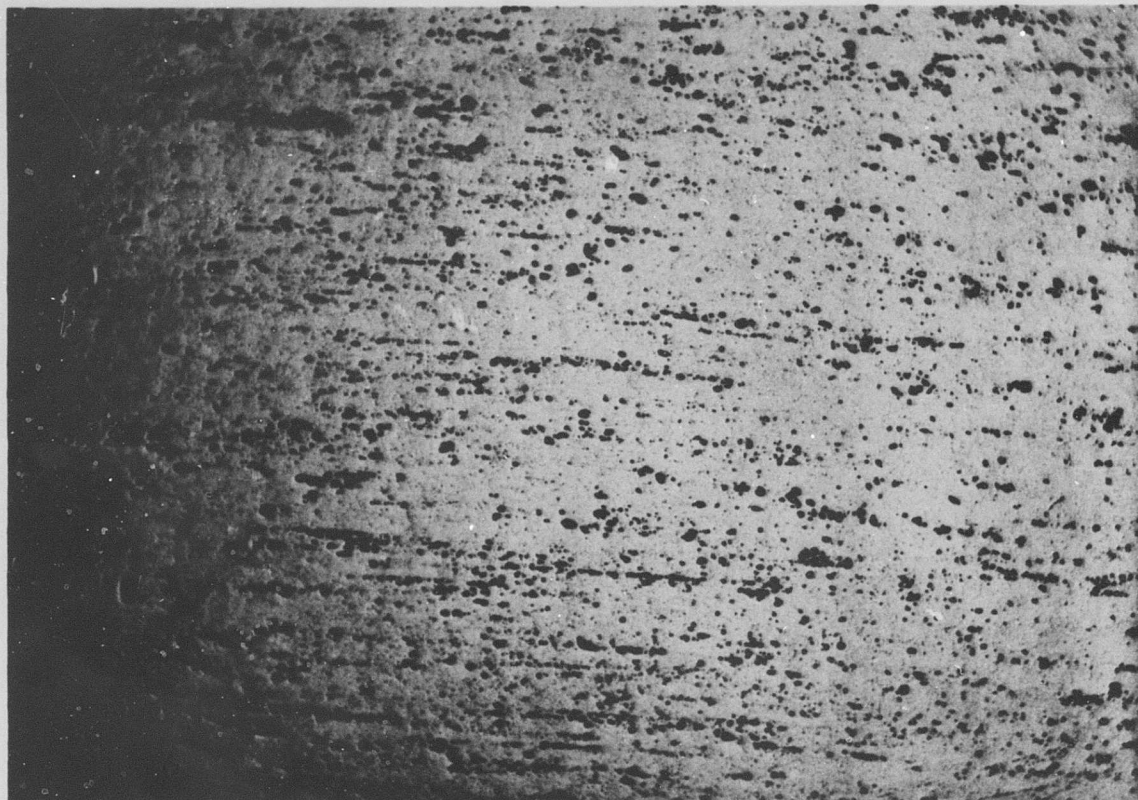
Material Aluminum 6061-T6 Neg.No. W19  
Specimen TWU 3-36 Neg.Mag. 100X  
Etchant Keller's Photo Enlargement None

The microstructure shows the aluminum matrix with inclusions and Al-Si eutectic.

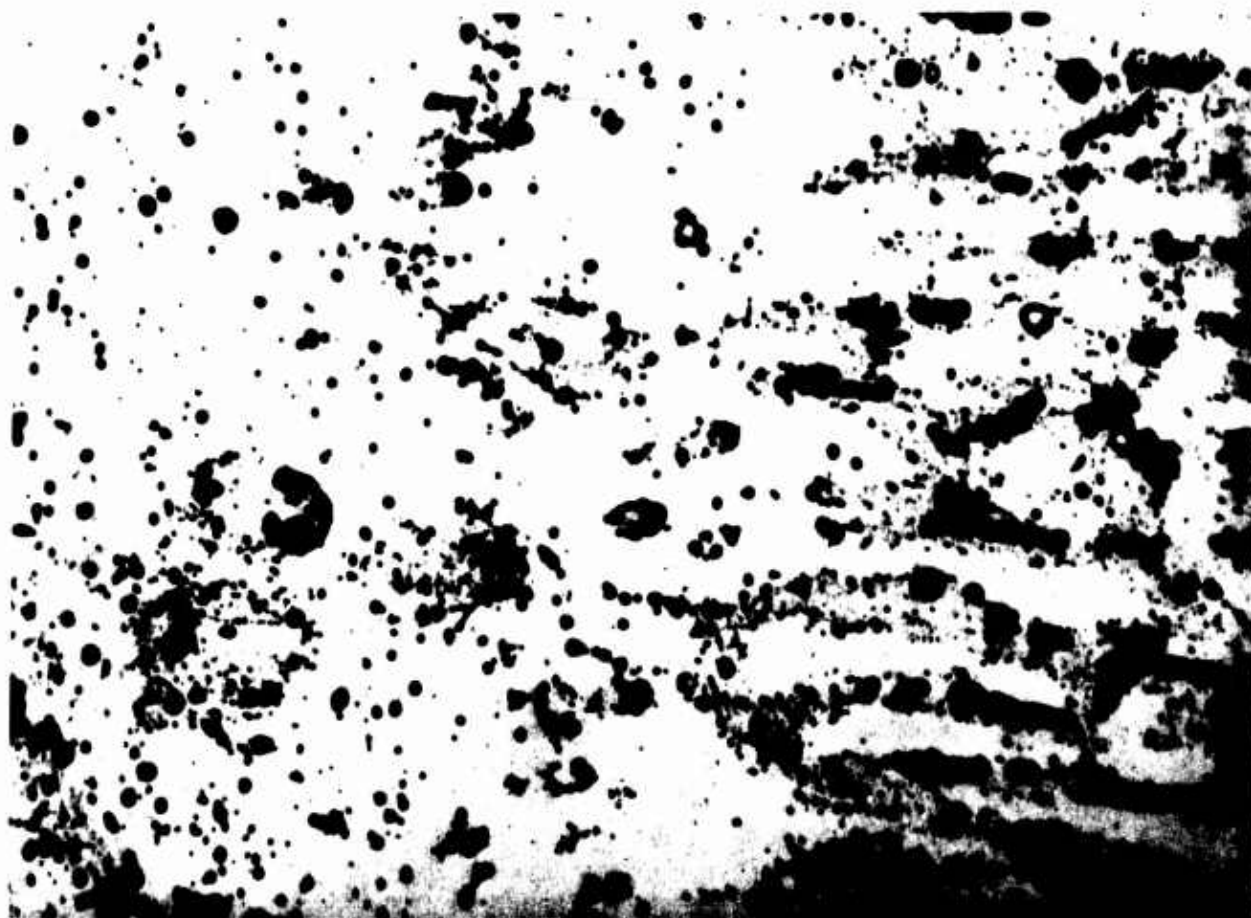
Material Aluminum 6061-T6 Neg.No. W49  
Specimen TWU 3-36 Neg.Mag. 1,000X  
Etchant Keller's Photo Enlargement None

The microstructure of the parent metal/weld interface shows the aluminum matrix with inclusions and eutectic.

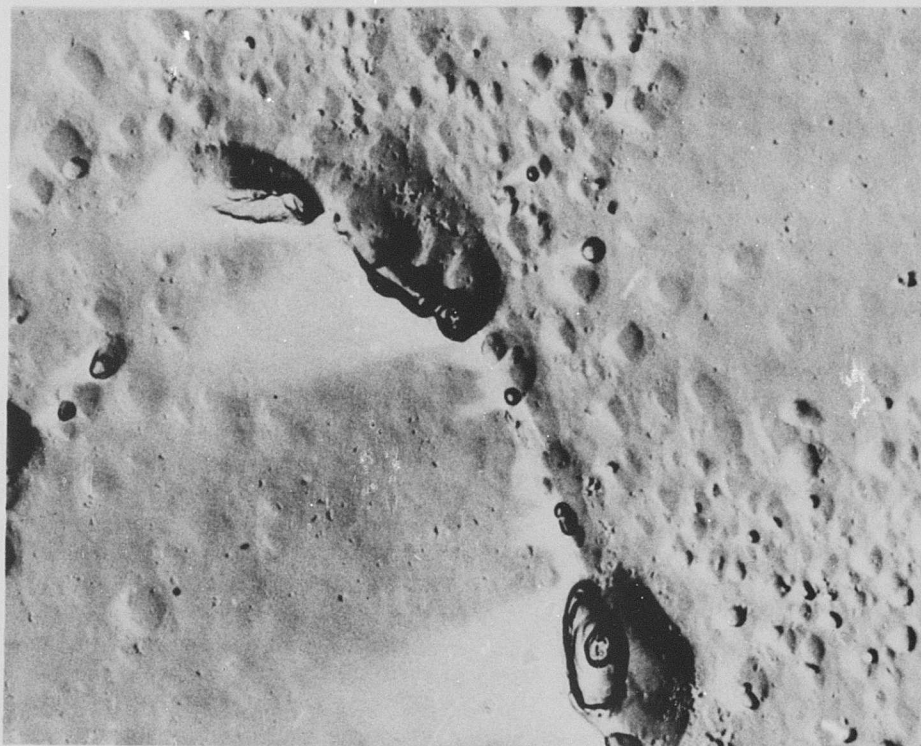
Material	Aluminum 6061-T6	Neg.No.	102-1
Specimen	TWU 3-36	Neg.Mag.	7,500X
Etchant	Keller's	Photo Enlargement	2X

The electron micrograph of the weld area shows a matrix of solid-solution aluminum, eutectic in the grain boundary, and insolubles.

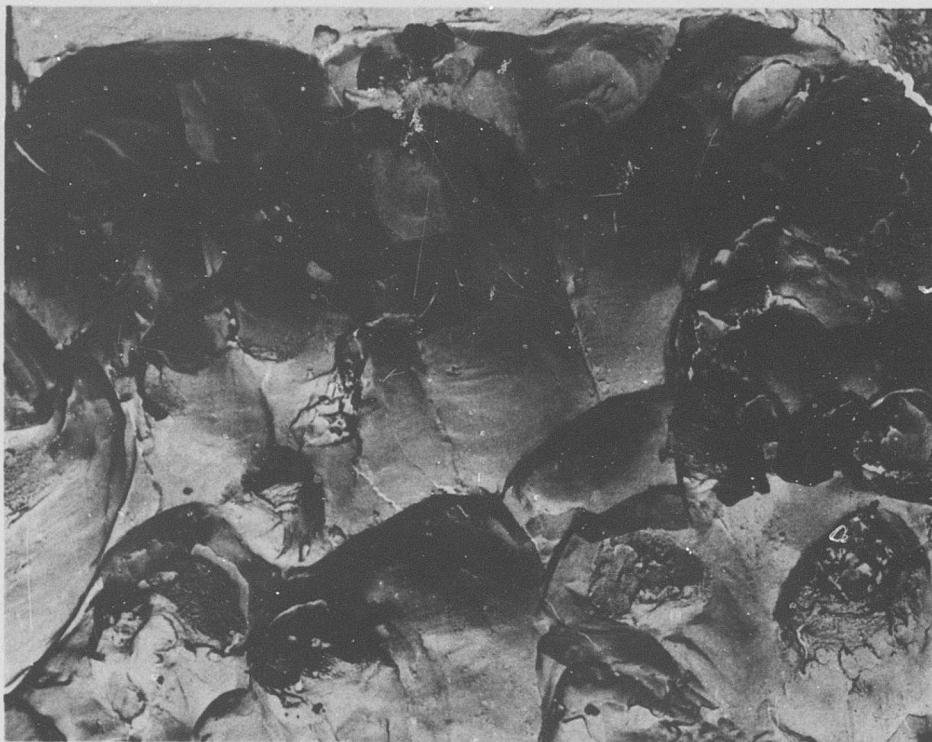
Material	Aluminum 6061-T6	Neg.No.	99-2
Specimen	TWN 3-46	Neg.Mag.	2,100X
Etchant	None	Photo Enlargement	2X

The notched specimen fracture surface shows a dimple rupture with eutectic at the origins of the voids.

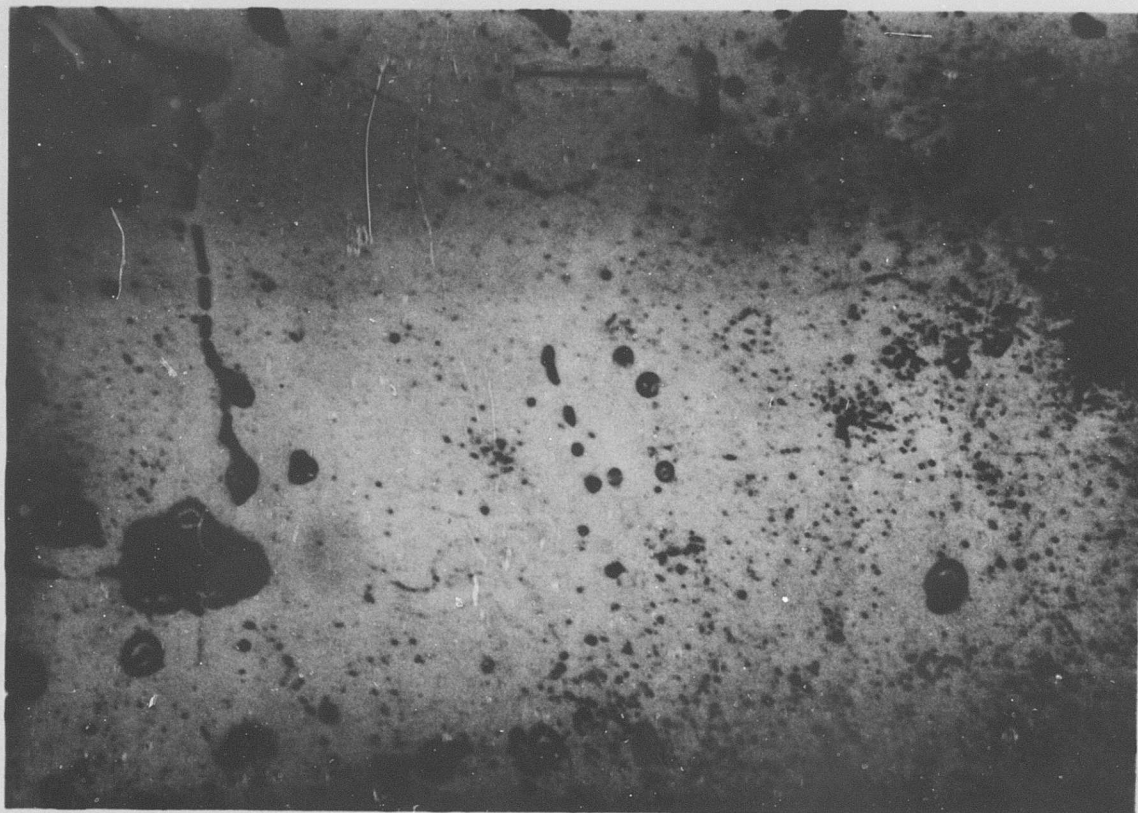
Material Aluminum 6061-T6 Neg.No. W52  
Specimen LWU 726 Neg.Mag. 1,000X  
Etchant Keller's Photo Enlargement None

The microstructure shows the solid-solution aluminum matrix, the Al-Si eutectic in the grain boundaries of the weld material, and insoluble particles.

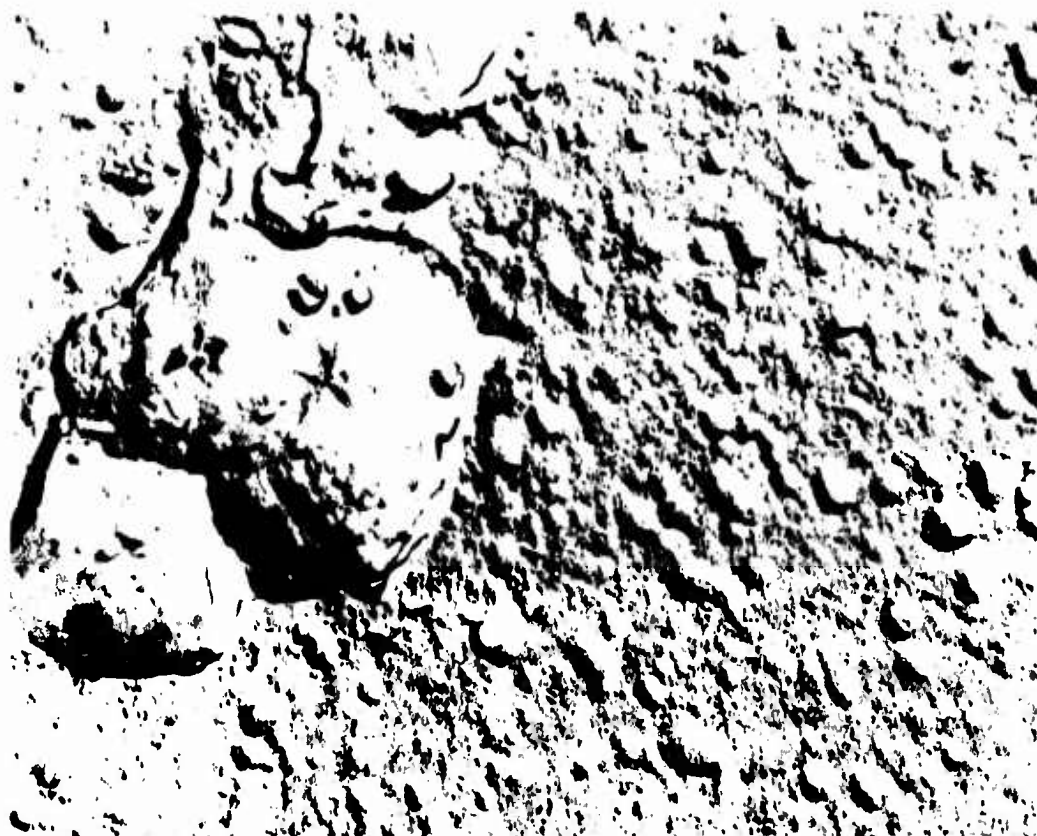
Material Aluminum 6061-T6 Neg.No. 101-10  
Specimen LWU 726 Neg.Mag. 7,500X  
Etchant Keller's Photo Enlargement 2X

The microstructure shows the solid-solution aluminum matrix and a large inclusion site.

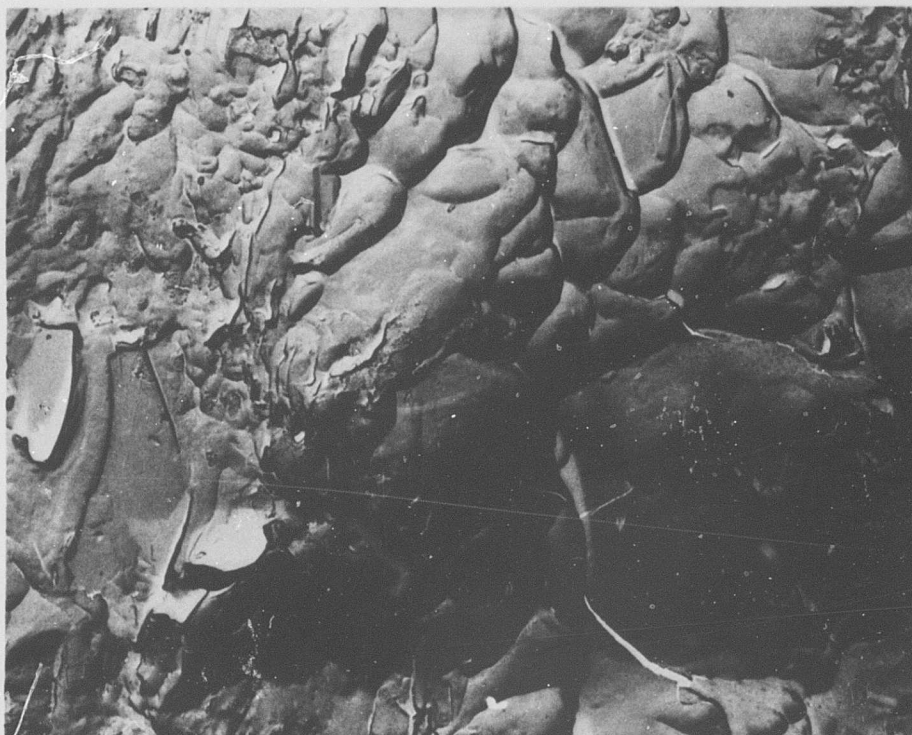
Material	Aluminum 6061-T6	Neg.No.	94-9
Specimen	LWU 726	Neg.Mag.	2,100X
Etchant	None	Photo Enlargement	2X

The fractograph of this area near the center of the specimen shows a dimple rupture. Certain areas show the failure through the brittle eutectic; the fracture was transgranular within this area.

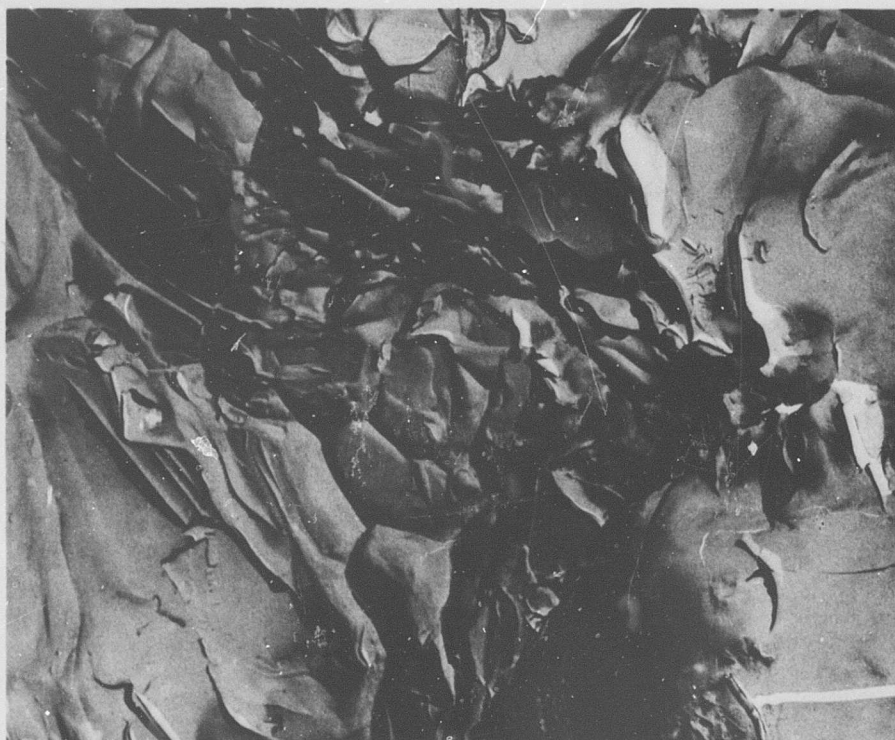
Material Aluminum 6061-T6 Neg.No. 94-10  
Specimen LWU 726 Neg.Mag. 2,100X  
Etchant None Photo Enlargement 2X

The fracture shown in this photo, taken of an area near the edge, is almost entirely through and around the brittle eutectic phase.

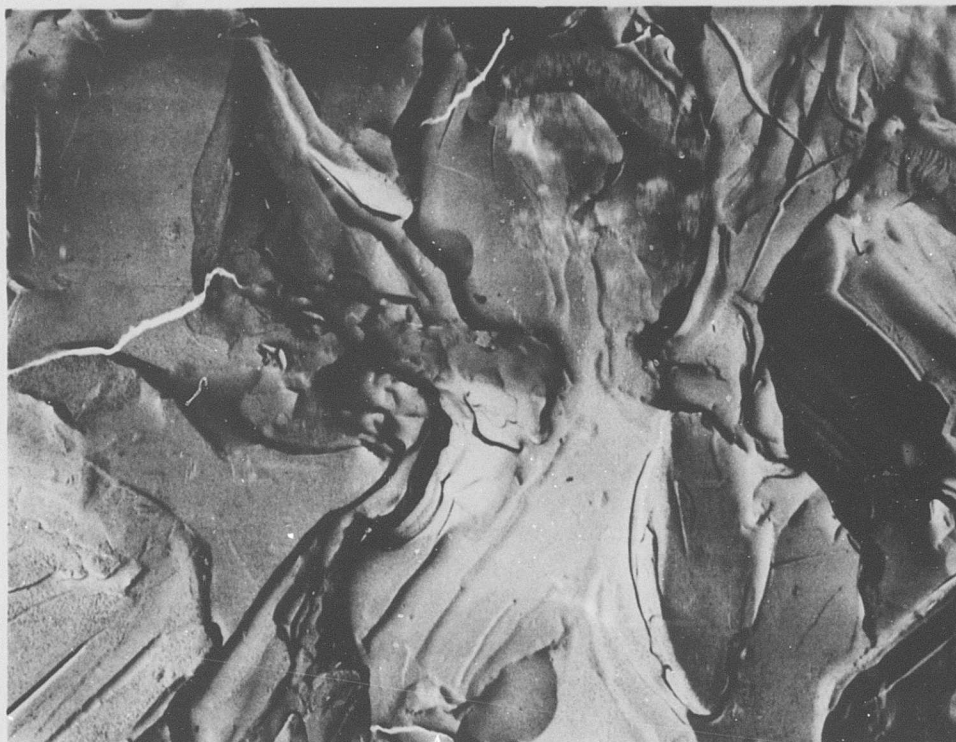
Material Aluminum 6061-T6 Neg.No. 99-10  
Specimen LWN 727 Neg.Mag. 2,100X  
Etchant None Photo Enlargement 2X

The fracture of the notched specimen is through and around the brittle eutectic.

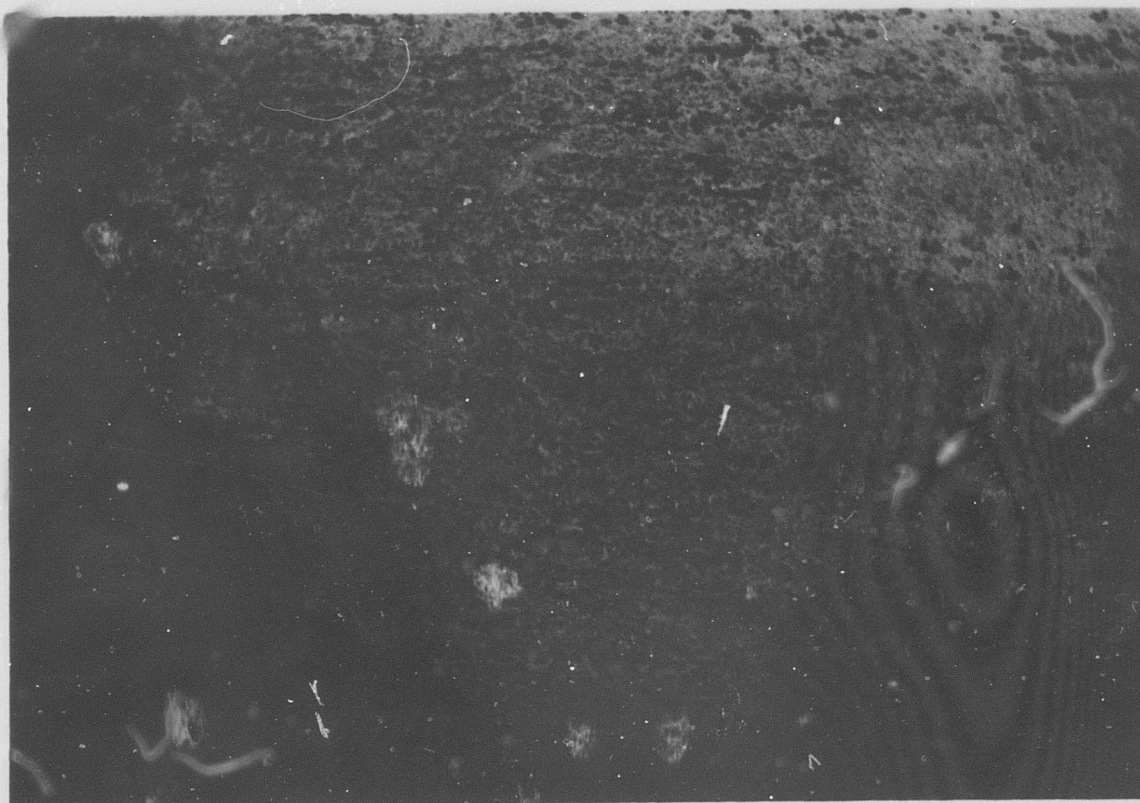
Material Aluminum 6061-T6 Neg.No. W16  
Specimen TW U 717 Neg.Mag. 100X  
Etchant Keller's Photo Enlargement None

The microstructure in the unstrained area shows the solid-solution aluminum matrix and insolubles.

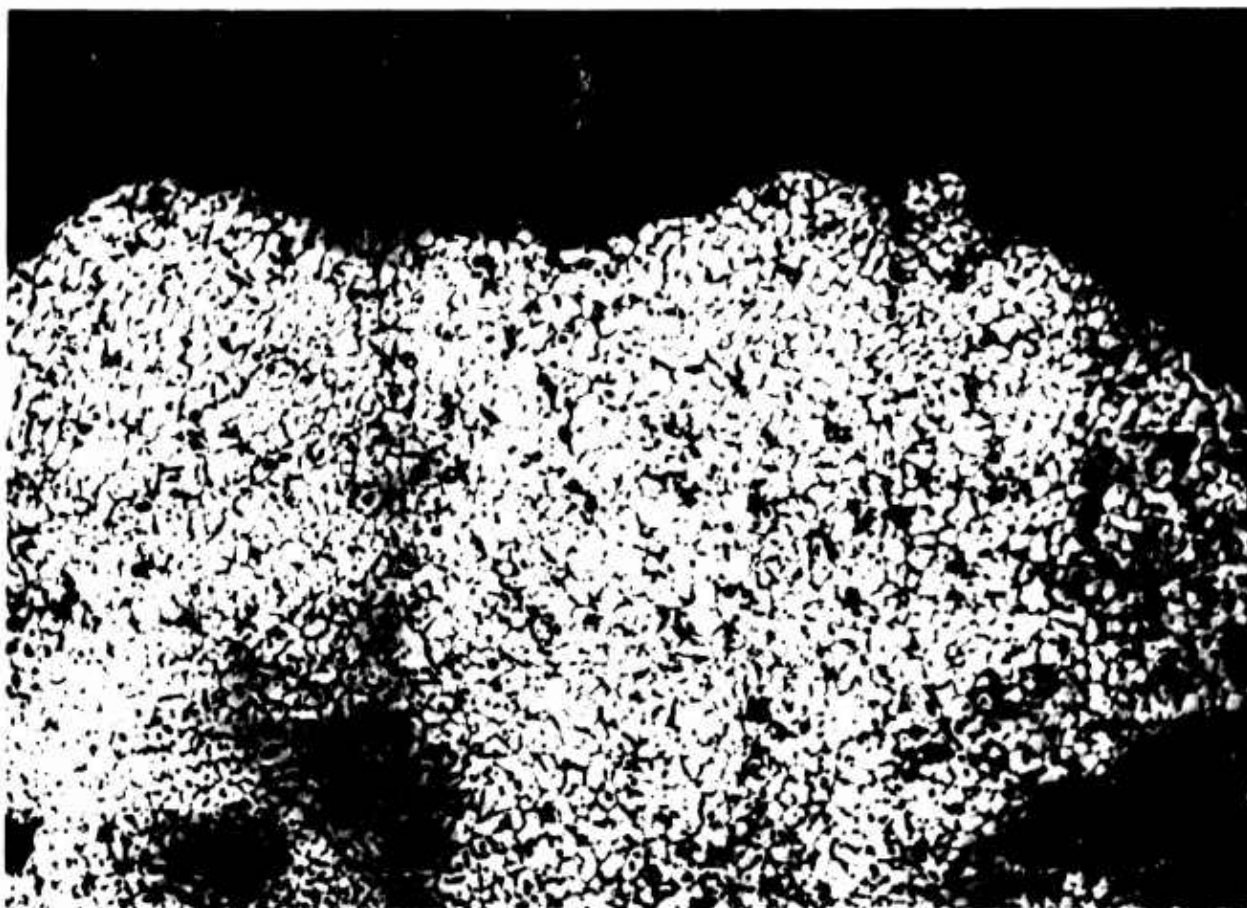
Material Aluminum 6061-T6 Neg.No. W41  
Specimen TWU 717 Neg.Mag. 100X  
Etchant Keller's Photo Enlargement None

The fracture profile shows a fracture path that is primarily intergranular through and along the brittle eutectic.

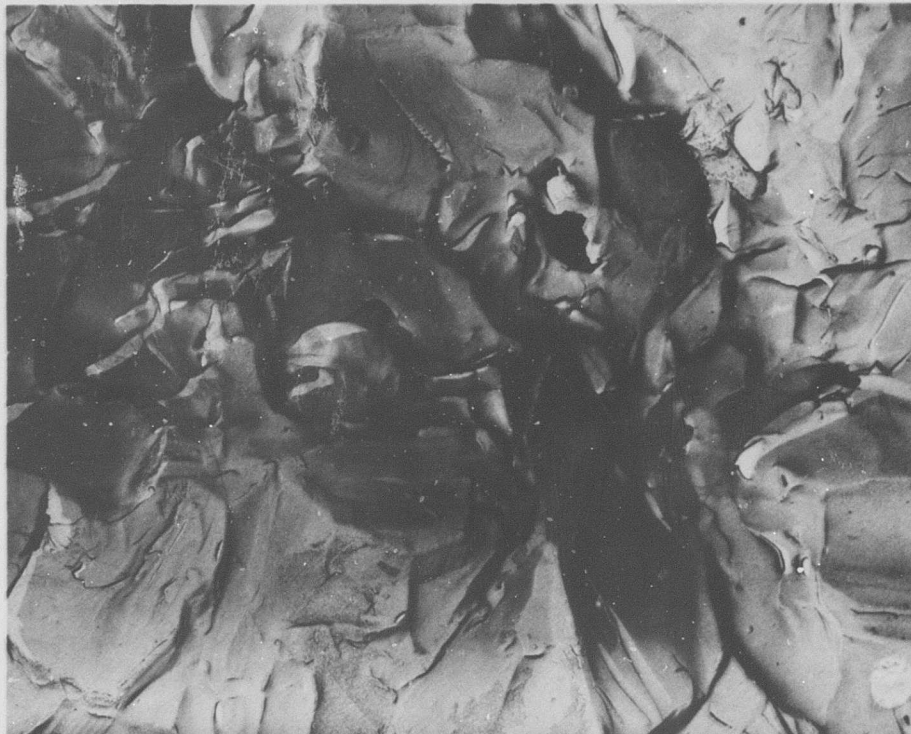
Material Aluminum 6061-T6 Neg.No. 94-4  
Specimen TWU 717 Neg.Mag. 2,100X  
Etchant None Photo Enlargement 2X

The fracture at the center of the specimen is mainly through the brittle eutectic and along the eutectic/matrix interface.

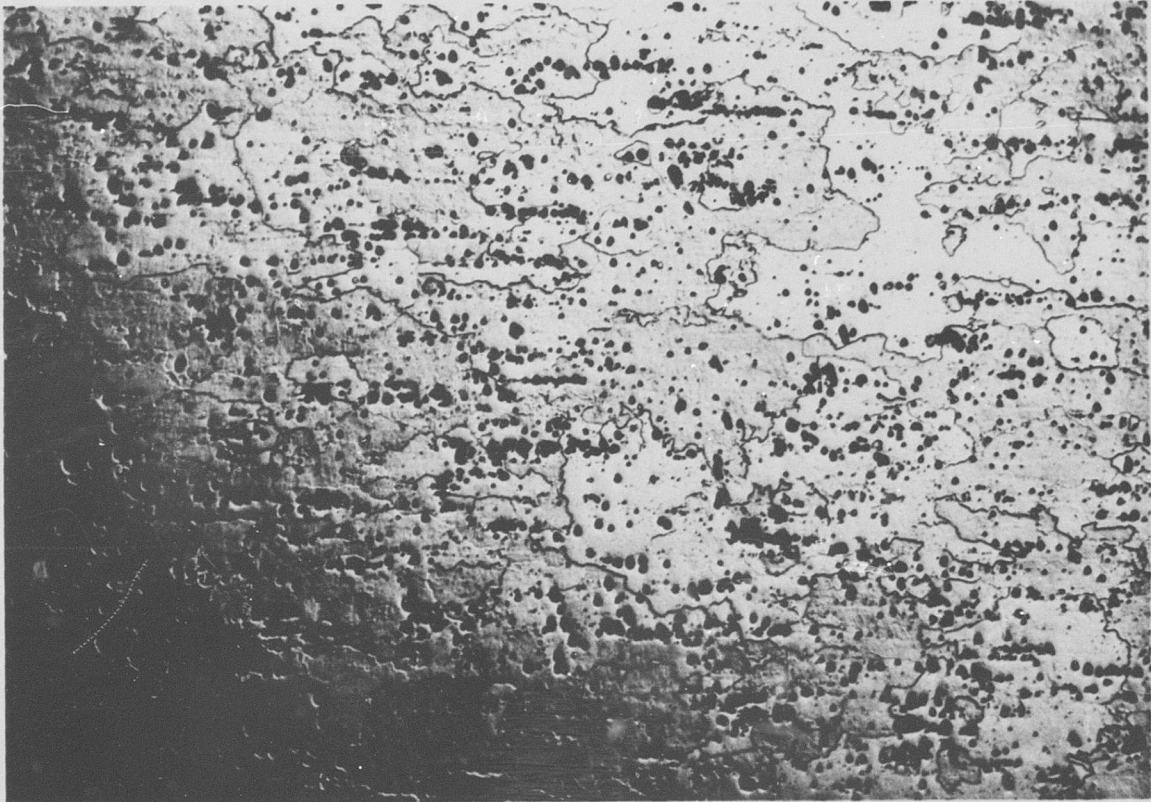
Material Aluminum 7075-T6 Neg.No. W24  
Specimen LU 106 Neg.Mag. 100X  
Etchant Keller's Photo Enlargement None

The optical micrograph shows a structure typical of the 7075-T6 wrought material - solid-solution aluminum containing a fine precipitate and nonmetallic inclusions. The primary hardening constituent is a Zn-Mg intermetallic precipitate.

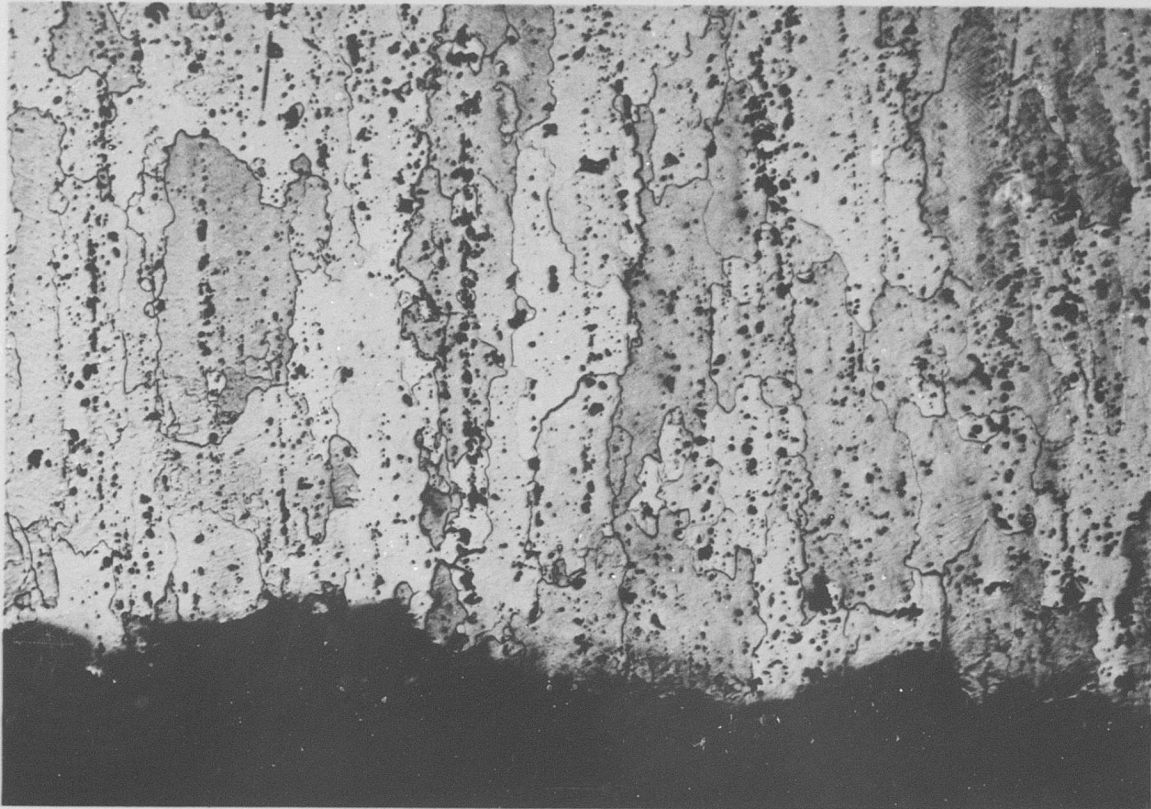
Material Aluminum 7075-T6 Neg.No. W56  
Specimen LU 106 Neg.Mag. 100X  
Etchant Keller's Photo Enlargement None

The path of the fracture is primarily transgranular.

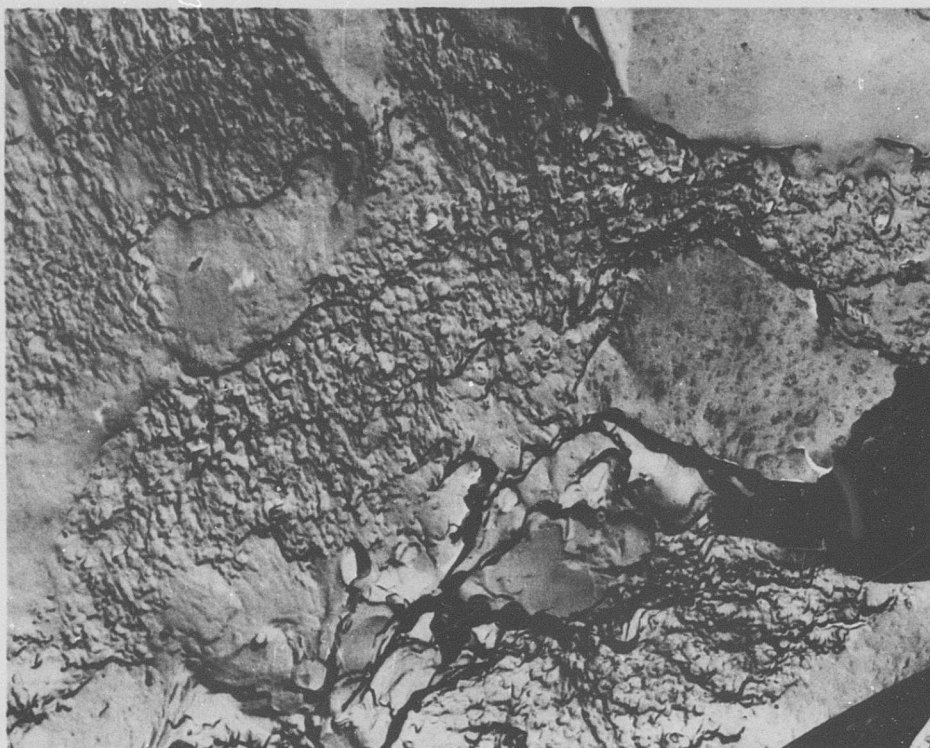
Material Aluminum 7075-T6 Neg.No. 95-8  
Specimen LU 106 Neg.Mag. 2,100X  
Etchant None Photo Enlargement 2X

The fracture near the edge of the specimen is made up of glide-plane decohesion, small oriented microvoids, and some intergranular areas. The fracture of an intermetallic compound is apparent.
